# EARTHVIEW

## **GROWTH AND INNOVATIONS IN EMISSIONS MONITORING**

**TIPRO Annual Conference  
March 29<sup>th</sup> 2022**

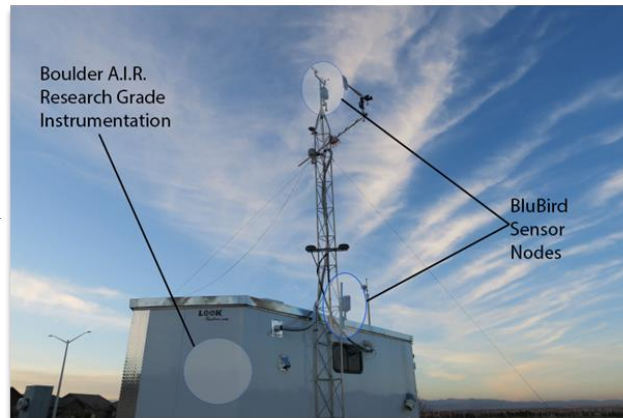
Prototype Testing and Validation

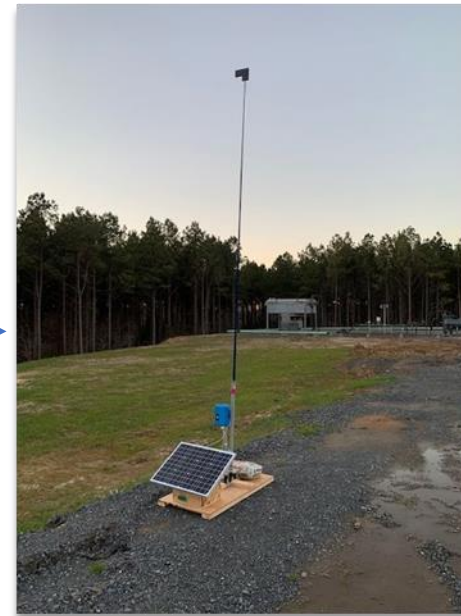
First Units Deployed to Active Production Facility ( March 2021)

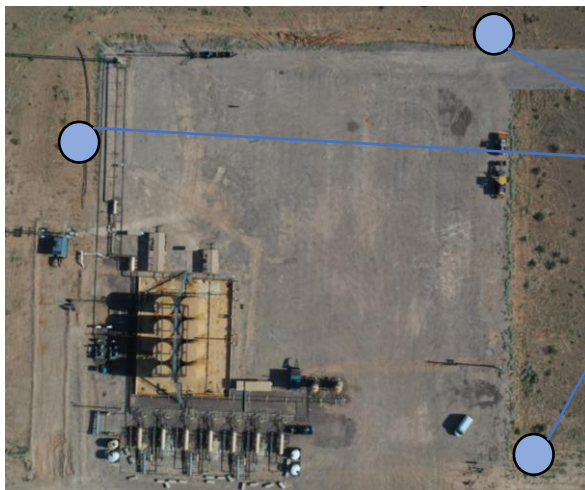
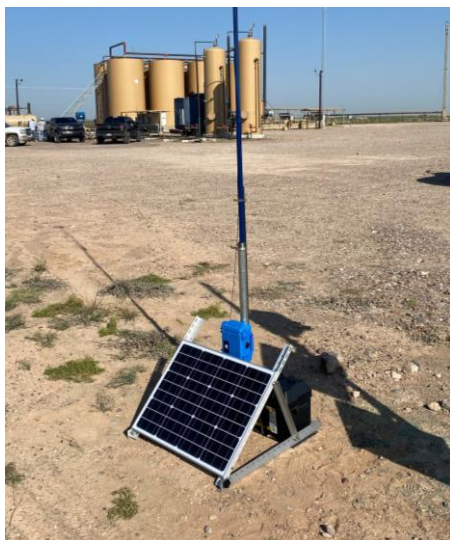
Continuous Methane and VOC Monitoring

## Field Deployed Hardware

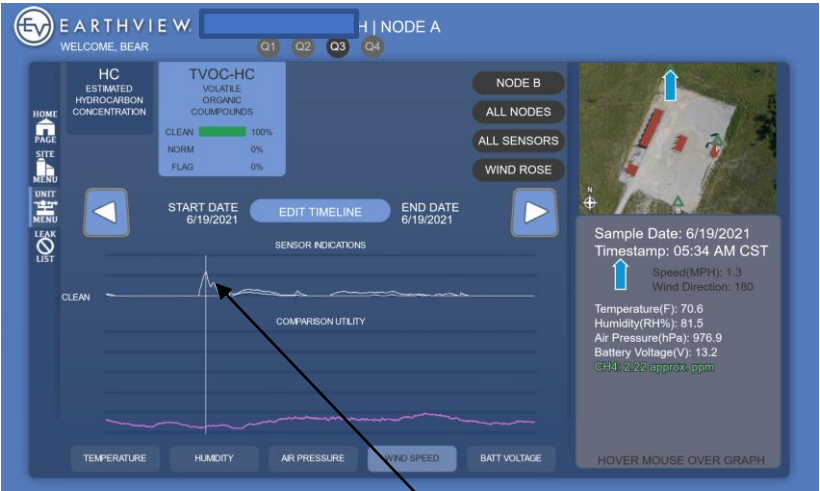
## Oil Load Event

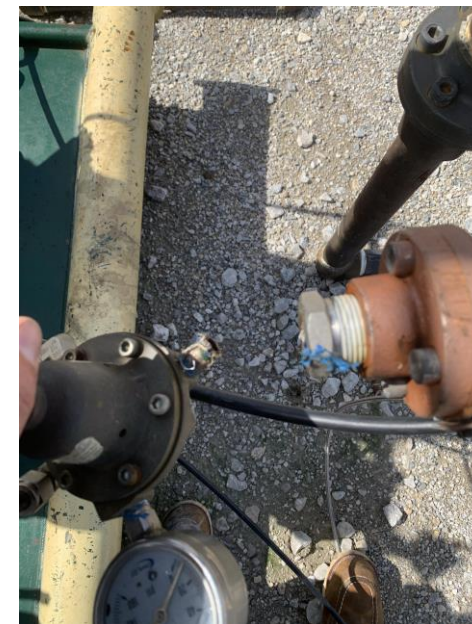
- Third event caught on 10/17, scrubber on compressor determined to also be leaking methane based on reading from the BluBird Sensors

| Date | Location | Nodes | Identified Source | Description |
|---|---|---|---|--|
| 10/17/2021 | 30 | P, A, B | Compressor (scrubber) | Readings on 10/16 and Sun 10/17, lease operator discovered leaking scrubber. Compressor is leased to XXX by vendor, mechanics called for repairs. |

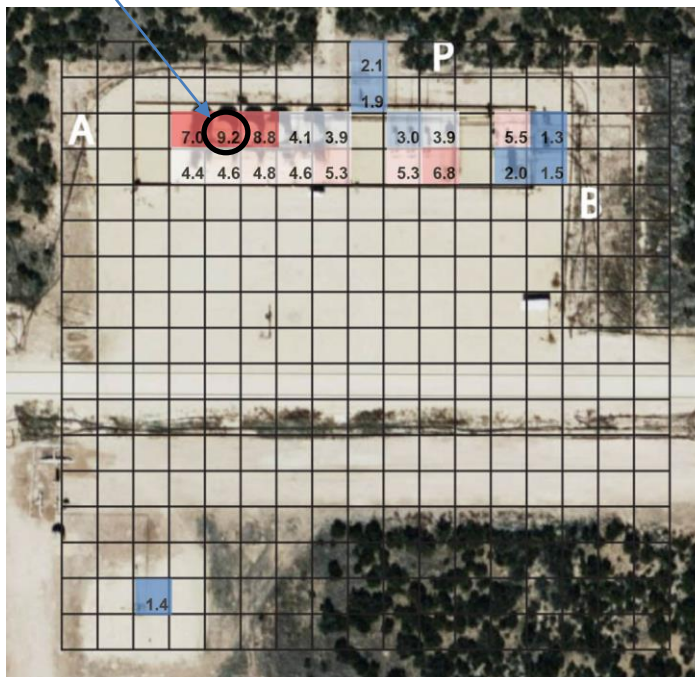
Figure 2: Localization- The highest number is most likely source location grid cell. Advanced software analyzes the data from all nodes to render these maps.

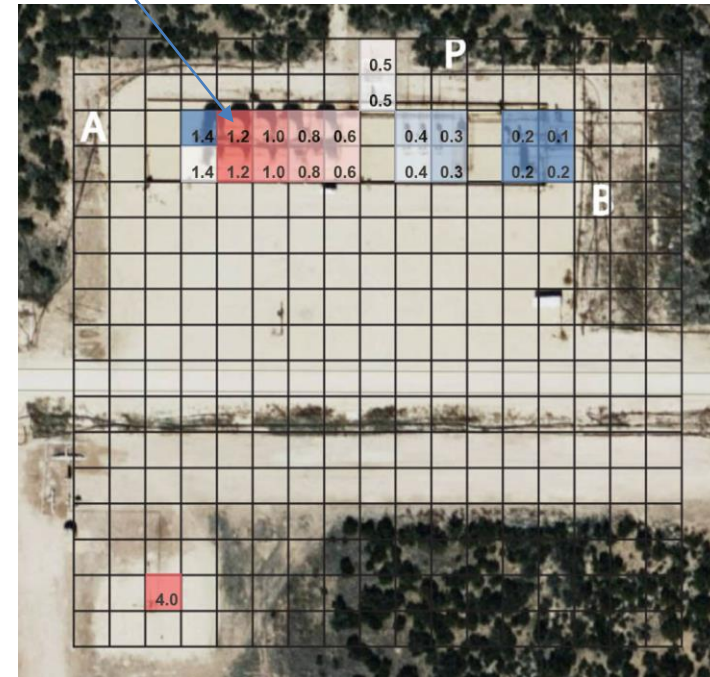
## 1.2 MCF / Hour

Figure 3: Quantification: The above figure shows the emission rate if the source were to be located in selected grid cell. (MCF / Hour Natural Gas)

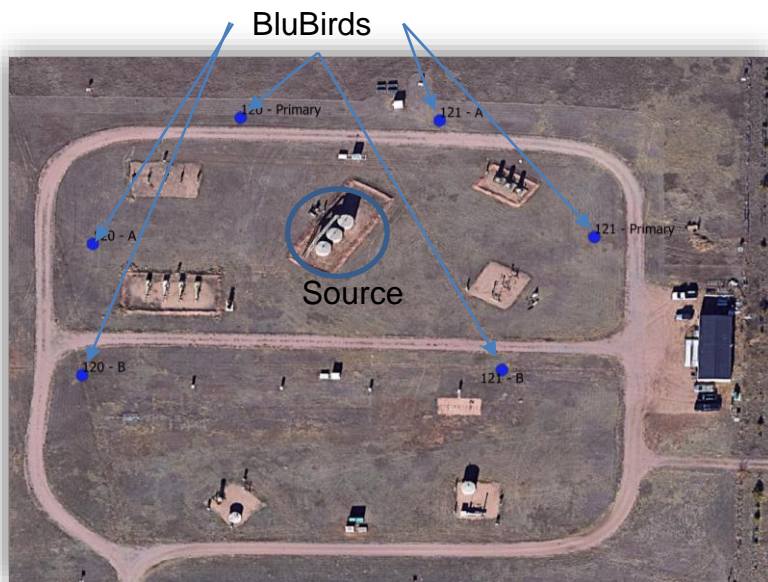
The BluBird Platform deployed to METEC in early January for 5 days with 4 total days of random methane releases by METEC staff.

1. What is the minimum detectable emission rate?
2. What is BluBird's practical detection limit of change in CH<sub>4</sub> concentration?
3. Can BluBird accurately quantify emission?
4. Verify Field Performance

1. The results suggest that BluBird can detect a natural gas emission rate of at least **1 kg/hr** from a source that is 20' high and 130' from the sensors. There are strong indications that BluBird is seeing rates as low as 0.25 kg/hr. Testing is currently underway.
2. In this test, a CH<sub>4</sub> increase above background of at least 0.3 ppm is detectable in our analysis.
3. The full results suggest that BluBird can quantify emission rates with good accuracy.
4. From these data, the BluBird system shows the ability to detect fine changes in CH<sub>4</sub> concentrations under field conditions, including the ability to account for changes in background air conditions.

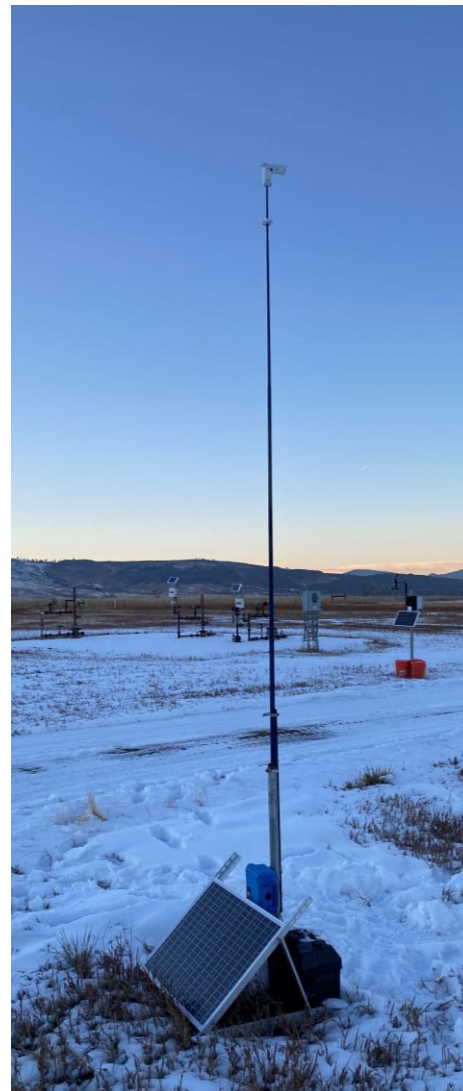
## Deployment

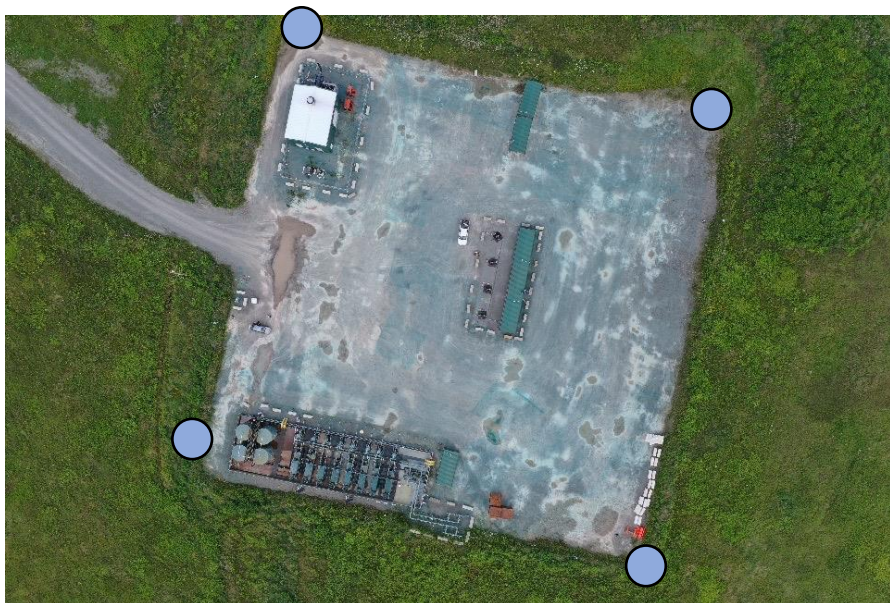
## **Pennsylvania**

Marcellus  
4 BluBirds

***Typical Layout: 3-4 BluBirds***  
***Possible Layouts: 1-8 BluBirds***

***The number of BluBird nodes is  
recommended based on the facility  
size and monitoring goals.***

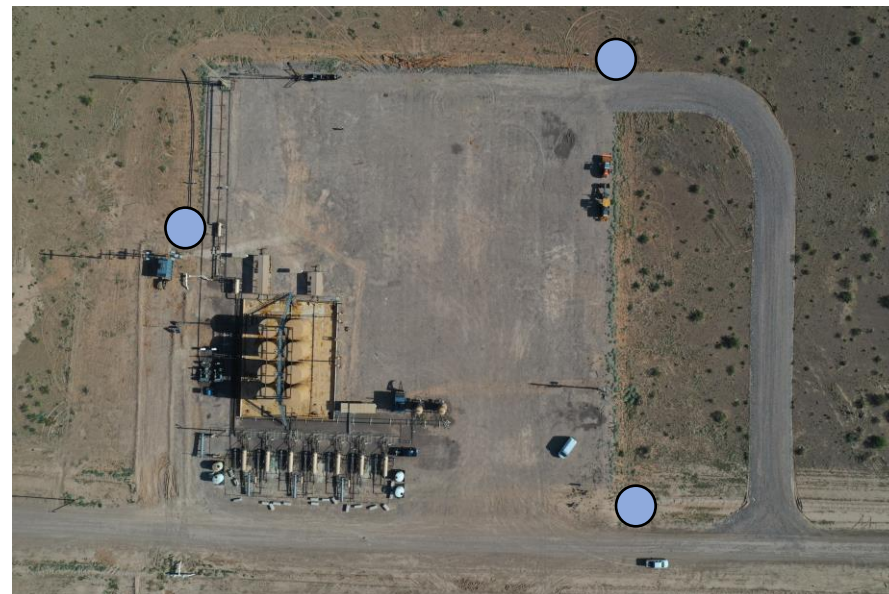
## **Texas**

Permian  
3 BluBirds
